NASA TN D-5138

PERFORMANCE AND CAVITATION DAMAGE OF AN AXIAL-FLOW PUMP IN 1500° F (1089 K) LIQUID SODIUM

by *Dean C. Reemsnyder, Walter S. Cunnan, and Carl Weigel*

*Lewis Research Center
Cleveland, Ohio*

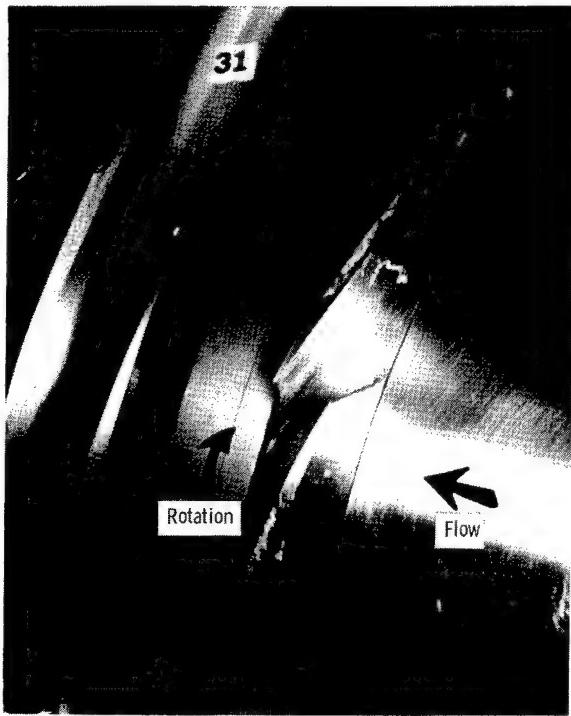
Figure 8. - Rotor cavitation formation in 80° F (300 K) water at 3450 rpm and flow coefficient of 0.143.

Photographs of the cavitation formations in water are shown in figure 8. The flow coefficient (0.143) and rotative speed (3450 rpm) for the water test were approximately the same as those for the sodium endurance test. These photographs indicate increasing amounts of vapor with a decreasing net positive suction head. The vapor is largely con-

fined to the region near the rotor tip and is generated by high velocities in the tip vortex. This tip cavitation is caused by the interaction between the main stream through flow and the cross flow through the blade-tip clearance space.

The photograph of figure 8(c) was taken at approximately the same flow coefficient, rotative speed, and net positive suction head as those for the sodium cavitation endurance test. In this figure, a small amount of vapor can be seen near the blade tip and leading edge on the suction surface of the middle blade. Visual observation of the operating rotor revealed that this vapor formed and collapsed in an irregular manner. Also, the tip vortex cavitation appeared to be confined to the flow channel because it did not cross the channel to impinge on the following blade.

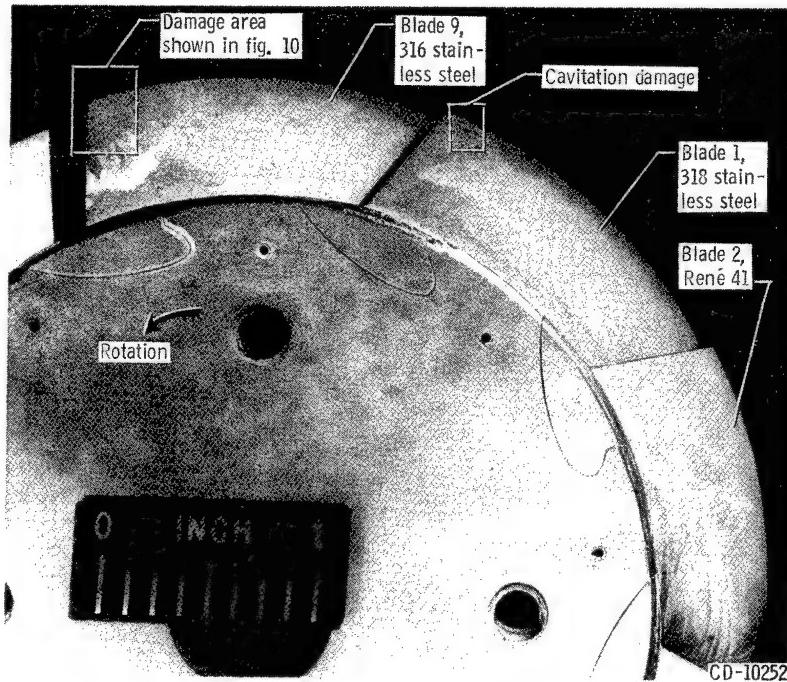
Figure 9. - Post-test suction surface of three rotor blades. (White areas are residual sodium oxide.)

Following the sodium endurance test, the blades were inspected for cavitation damage. A post-test photograph of the rotor showing the suction surfaces of three blades is presented in figure 9. Suction surface damage consisted of a few random pits except for an area near the blade-tip leading edge where damage was more severe (dashed outline on blade 9, fig. 9). Enlarged photographs of this area for the most severely damaged blade of each material are shown in figure 10. The white areas evident in figures 9 and 10 are residual sodium oxide. A comparison of the pretest photograph (fig. 10(a)) with the post-test photograph of blade 9 (fig. 10(b)) indicates a roughening of the blade surface that resulted from corrosion.

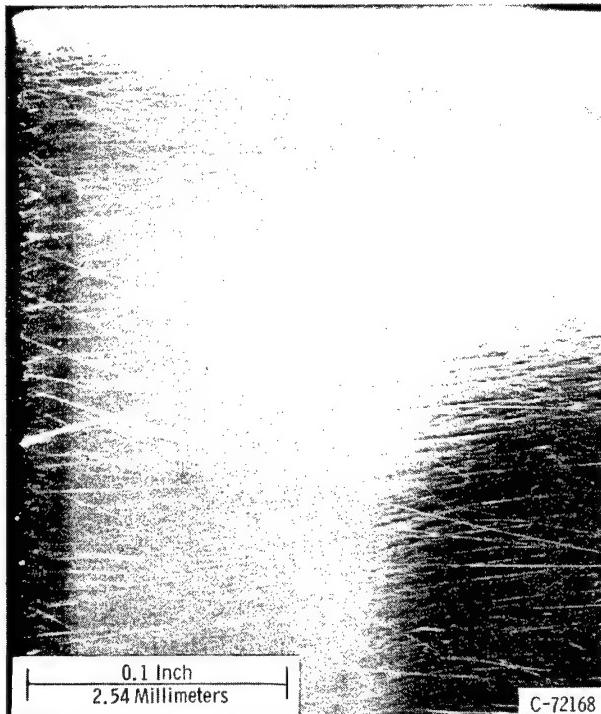
Figure 10. - Enlarged views of inlet tip suction surfaces of blades. (White areas are residual sodium oxide.)

The area where locally concentrated cavitation damage occurred was on the suction surface of the blade near the tip (fig. 10(c)). The damage area was elliptical in shape and was about 1/8 inch (3.18 mm), in chord direction, by about 0.040 inch (1.0 mm), in radial direction. The damage was apparently caused by the collapse of the vapor generated near the tip and leading edge of the blade. These vapor formations can be observed in the water photographs of figure 8(c) that were taken at conditions corresponding to the sodium cavitation endurance test.

René 41 was the most resistant of the three materials tested because it sustained the least amount of damage (fig. 10(d)). Damage evaluations of all nine blades indicated that

Surface roughening, which was observed over the entire surface of all blades, is attributed to corrosion attack by the high-temperature sodium. The corrosion attack may have been accelerated by the relatively high oxide content (above 50 ppm) during the initial cold-trapping operation at 1000° F (810 K). Post-test photomicrographs were taken of undamaged sections through three blade tips. The general surface profile is presented in figure 11. Surface roughening occurred to depths of about 0.001 inch (0.025 mm), and a zone of subsurface corrosion attack occurred to depths of about 0.002 inch (0.050 mm). The surfaces of the René 41 blades were much smoother and had less depth of penetration than either of the stainless steel blades.
